**NIST GCR 98-757**

# **Guide to Improved Earthquake Performance of Electric Power Systems**

Anshel Schiff  
Stanford University

September 1998

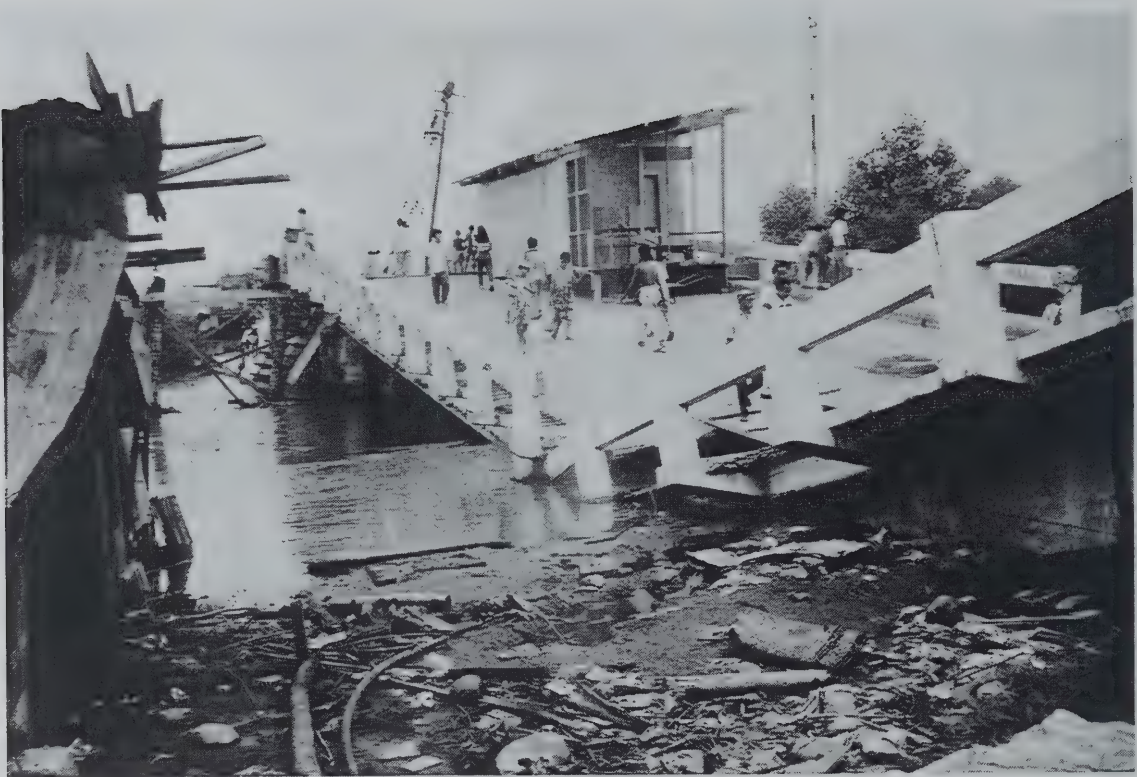
Figure 2.8 A pier in the river that supported a bridge sank below the surface when the soil liquefied.

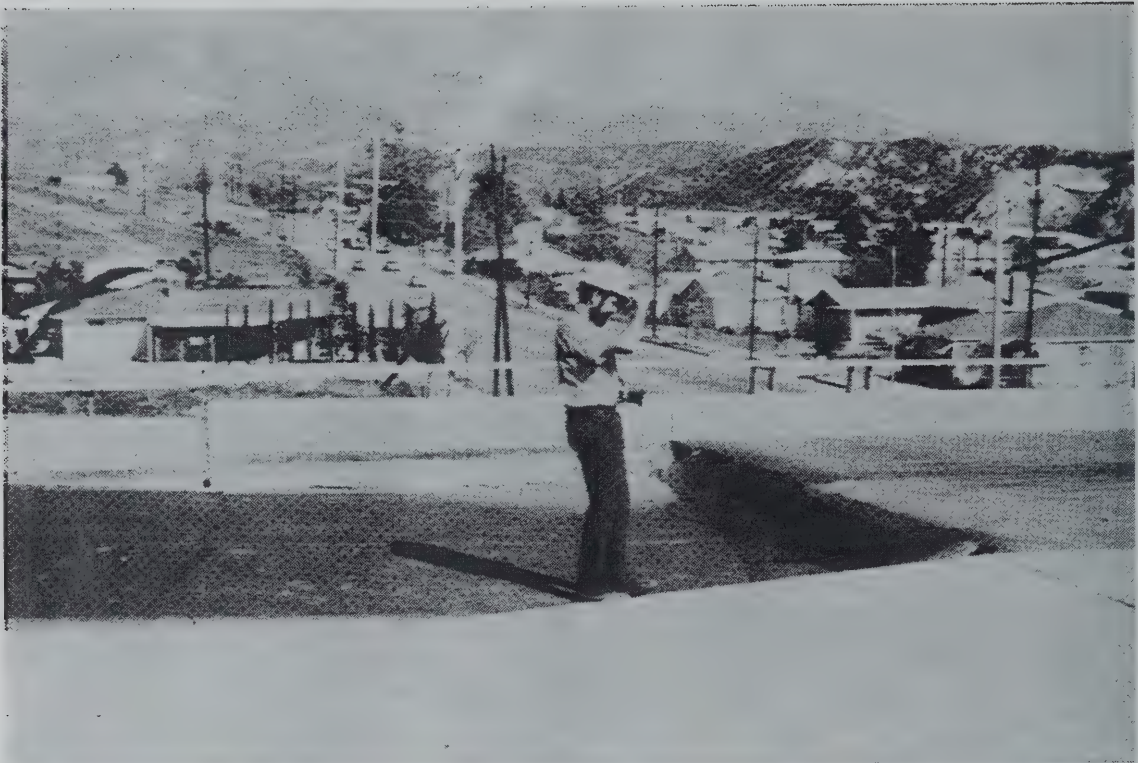
Figure 2.12 Subsidence of the road bed at bridge abutments is frequently observed after earthquakes.

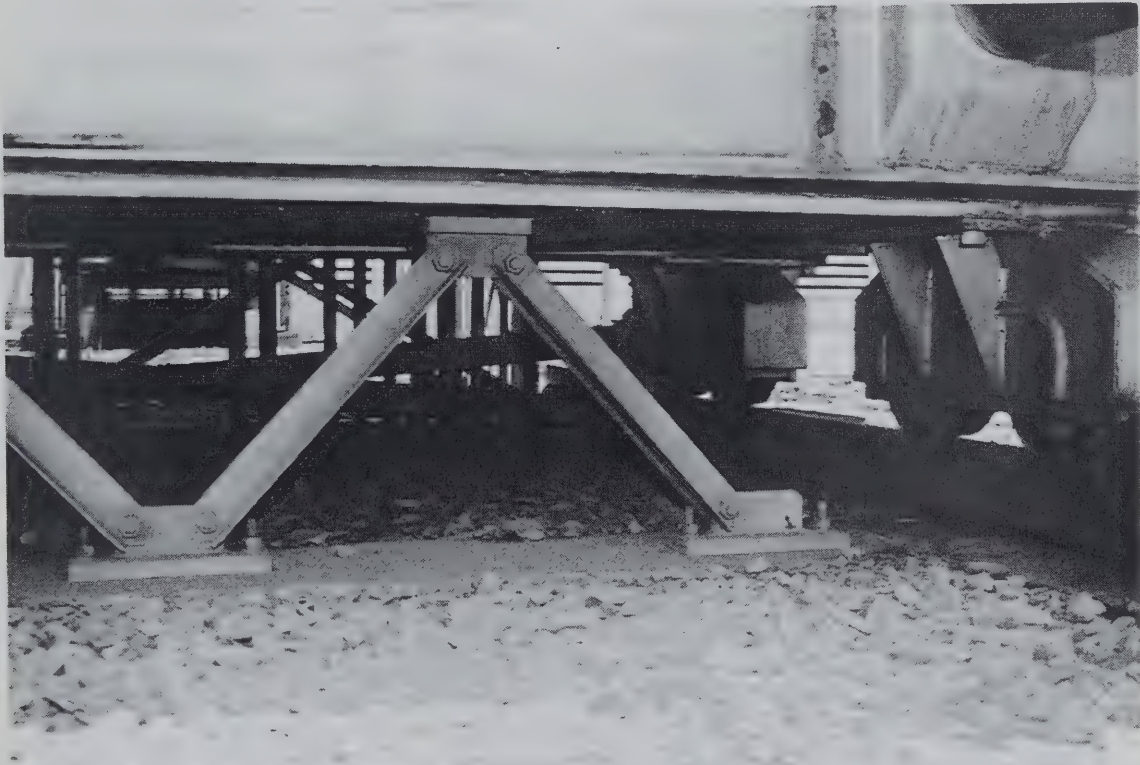
Figure 5.50 This frame at the other end of the transformer shown in Figure 5.50 is designed to resist transverse and vertical loads only.

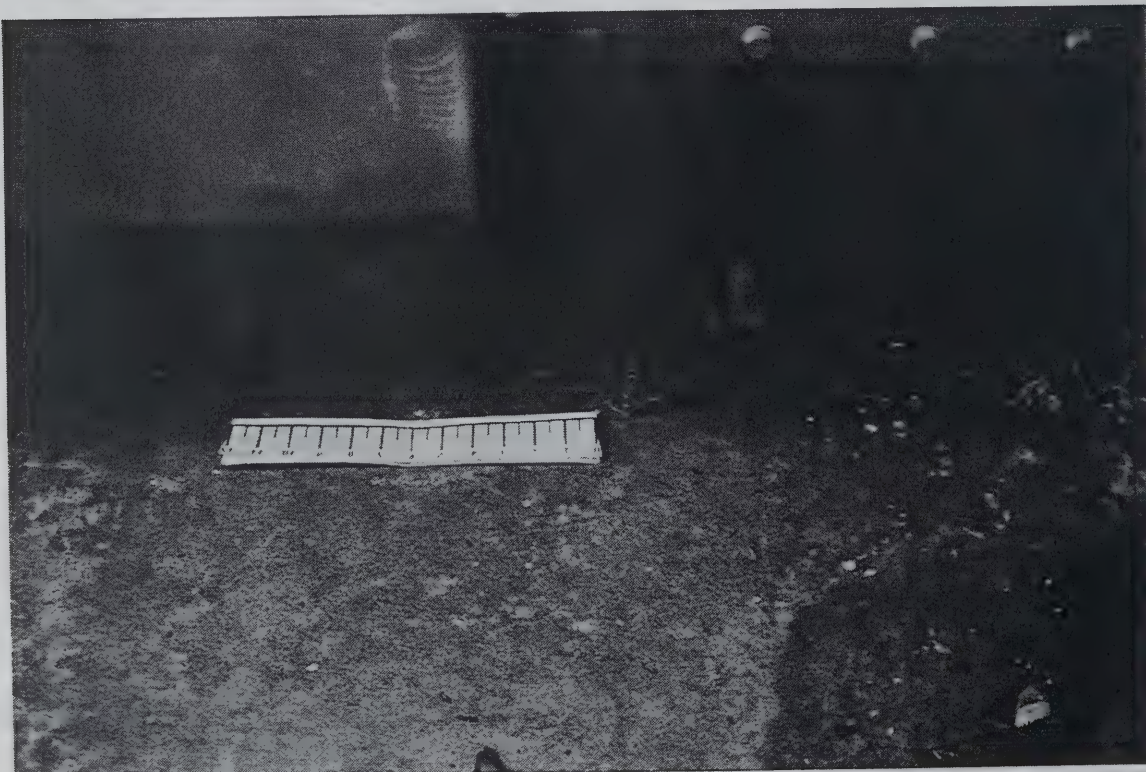
Figure 5.54 The control cables that enter the transformer through the foundation slab were almost sheared off due to the movement of the transformer.

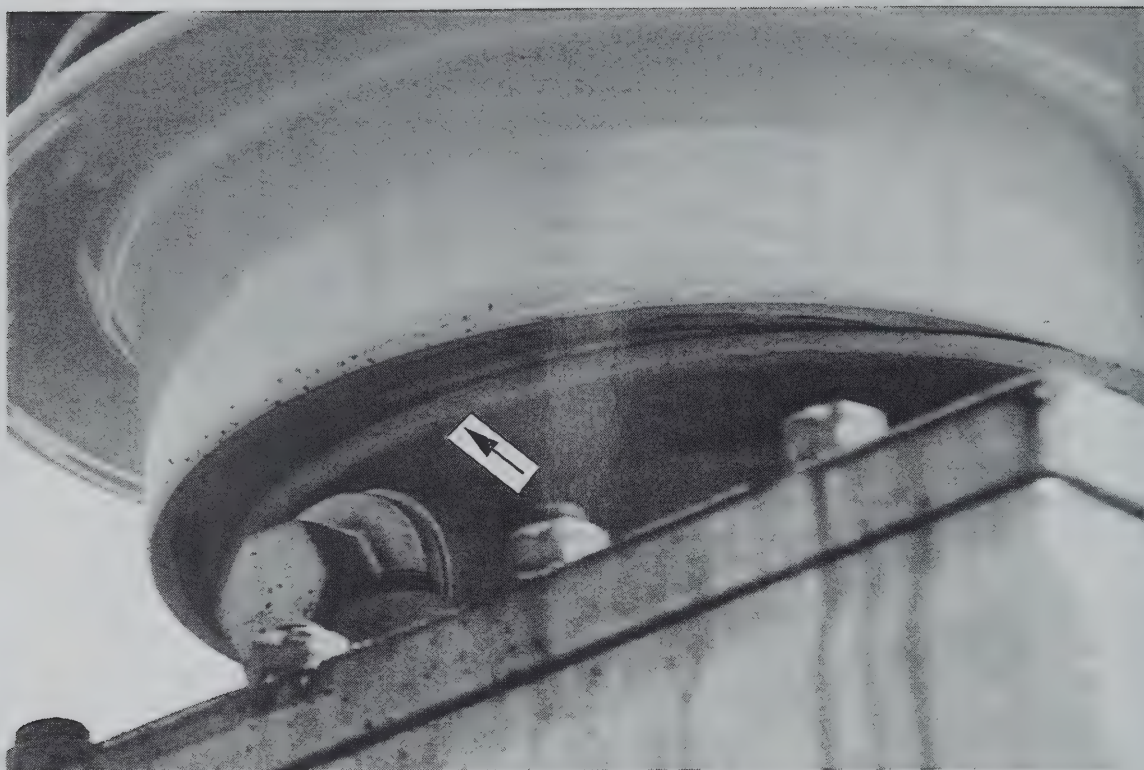
Figure 5.60 The porcelain of the bushing has slipped relative to its mounting flange. This typically results in oil leaking from the bushing.

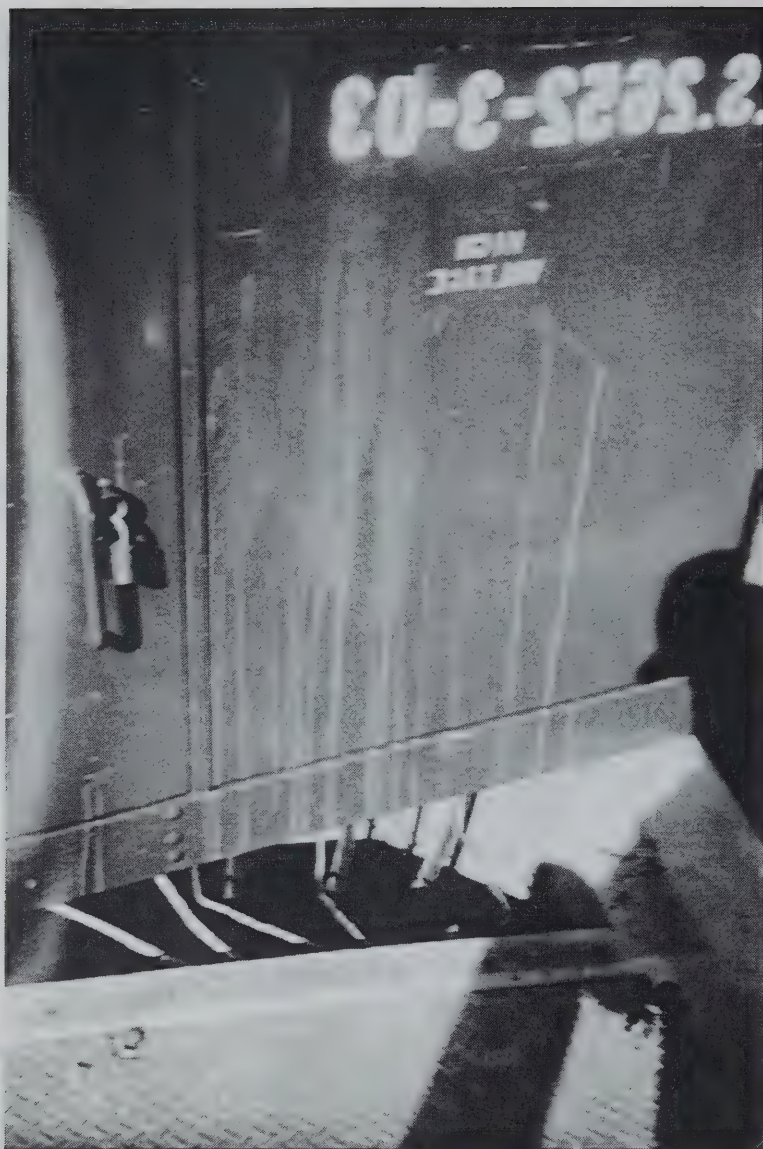
Figure 5.81 Slab-mounted distribution transformer was unanchored and slid on its slab.

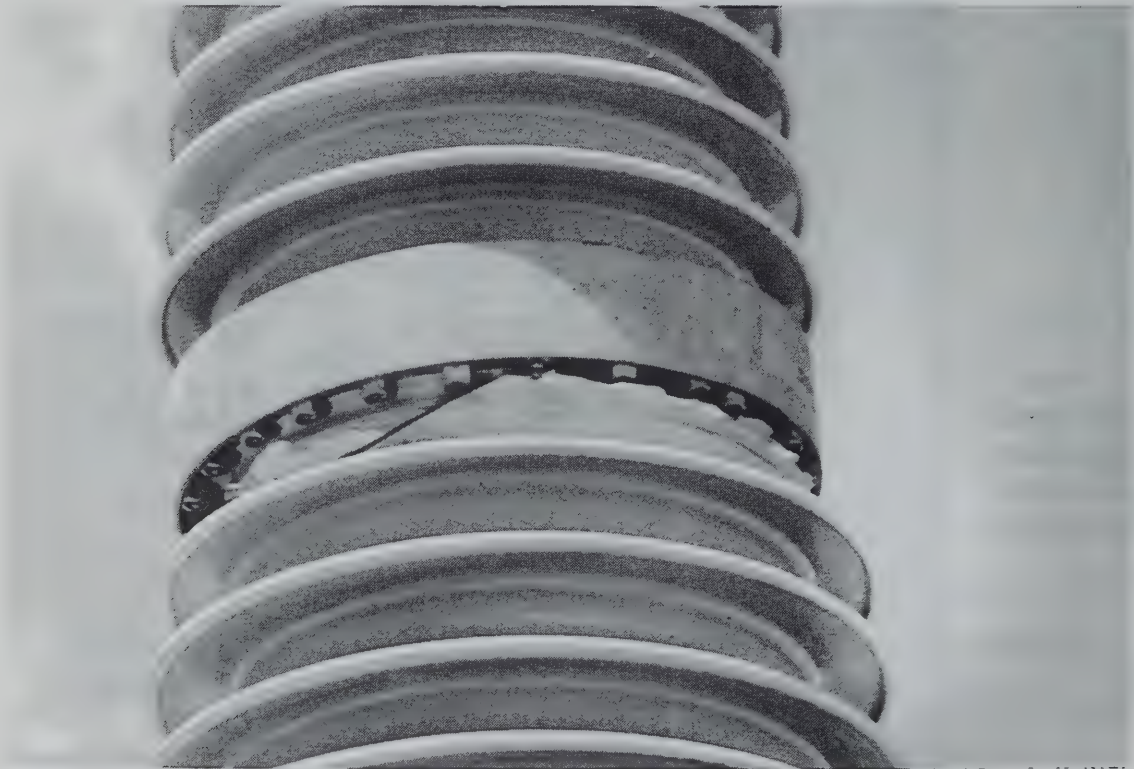
Figure 5.95 Conductor interaction loads probably caused the failure of the porcelain just below the flange between the upper and lower halves of the current transformer.

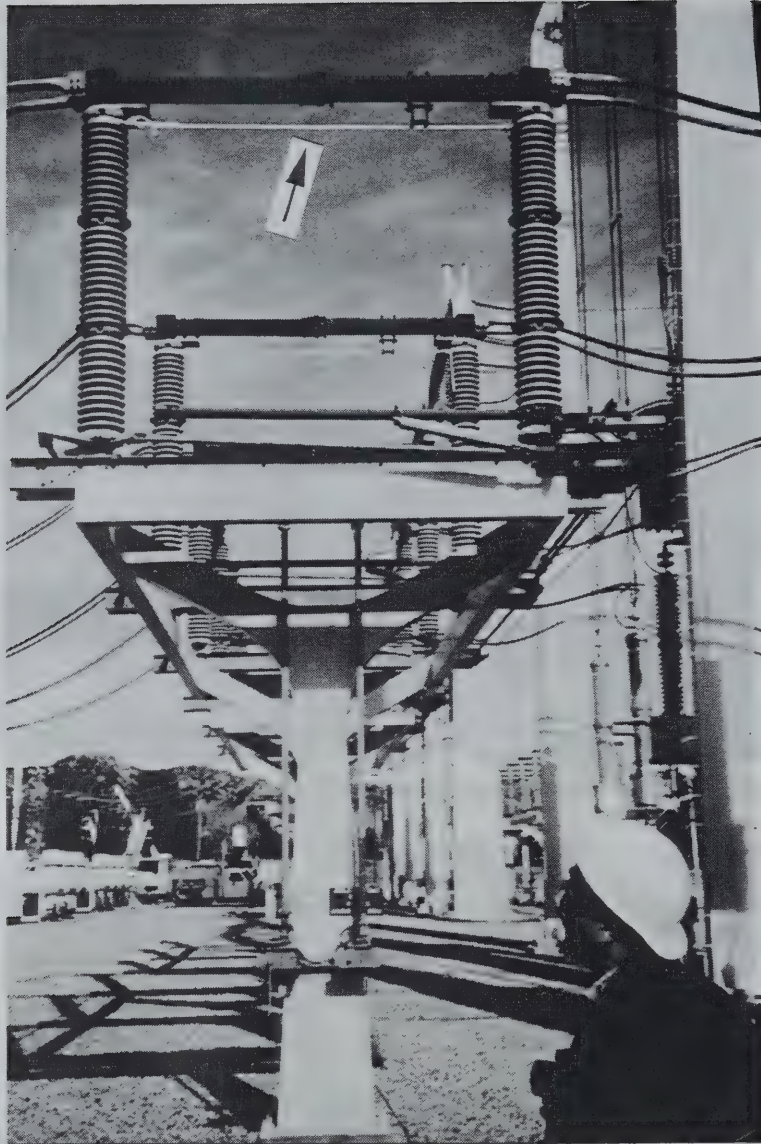
Figure 5.128 Cotton rope was used to keep deformed disconnect switches shown in Figure 5.124 closed so that service could be quickly restored.

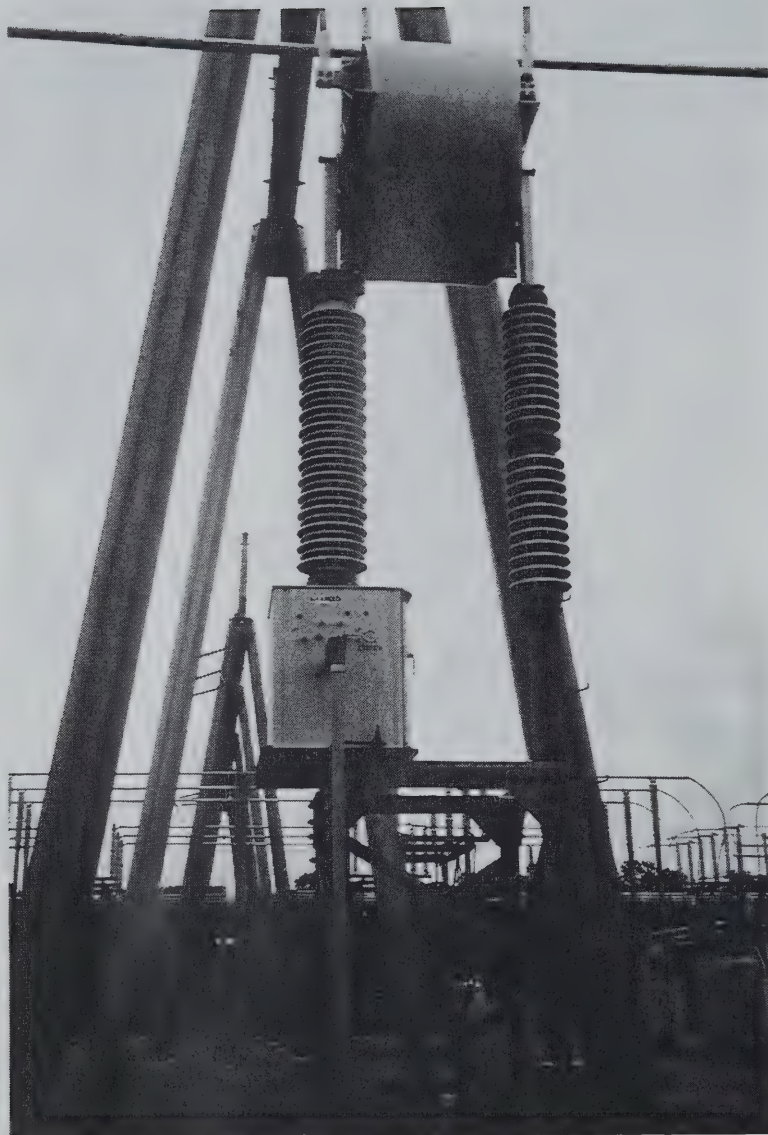
Figure 5.139 Wave trap partially supported by a current-voltage transformer.

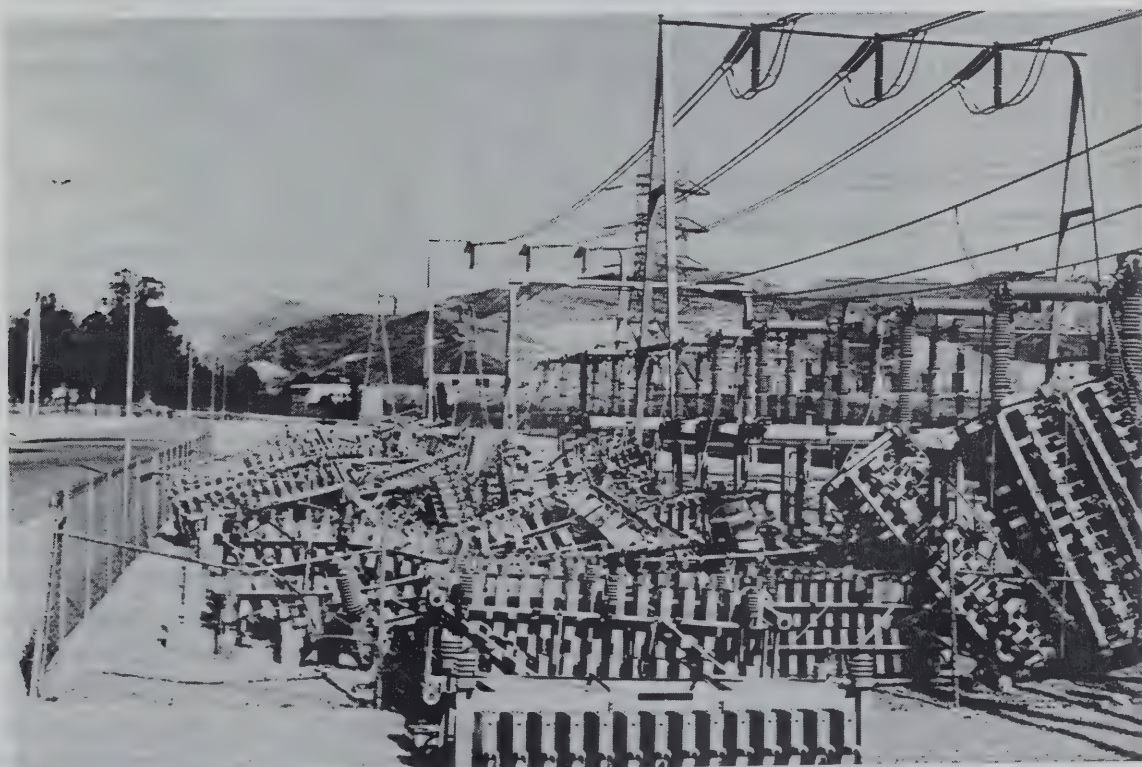
Figure 5.143 Capacitor rack welds failed causing the racks to collapse.

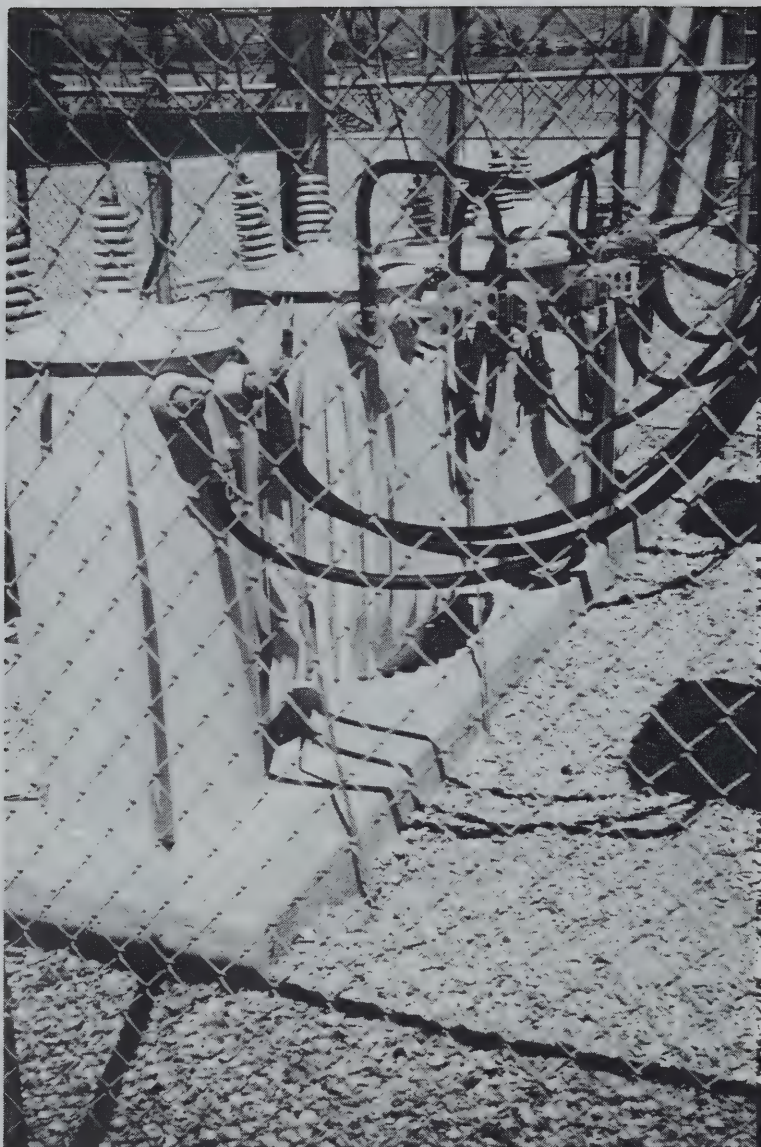
Figure 5.152 One of the most common methods of supporting the station transformers is by placing them on a concrete slab at grade without anchorage.

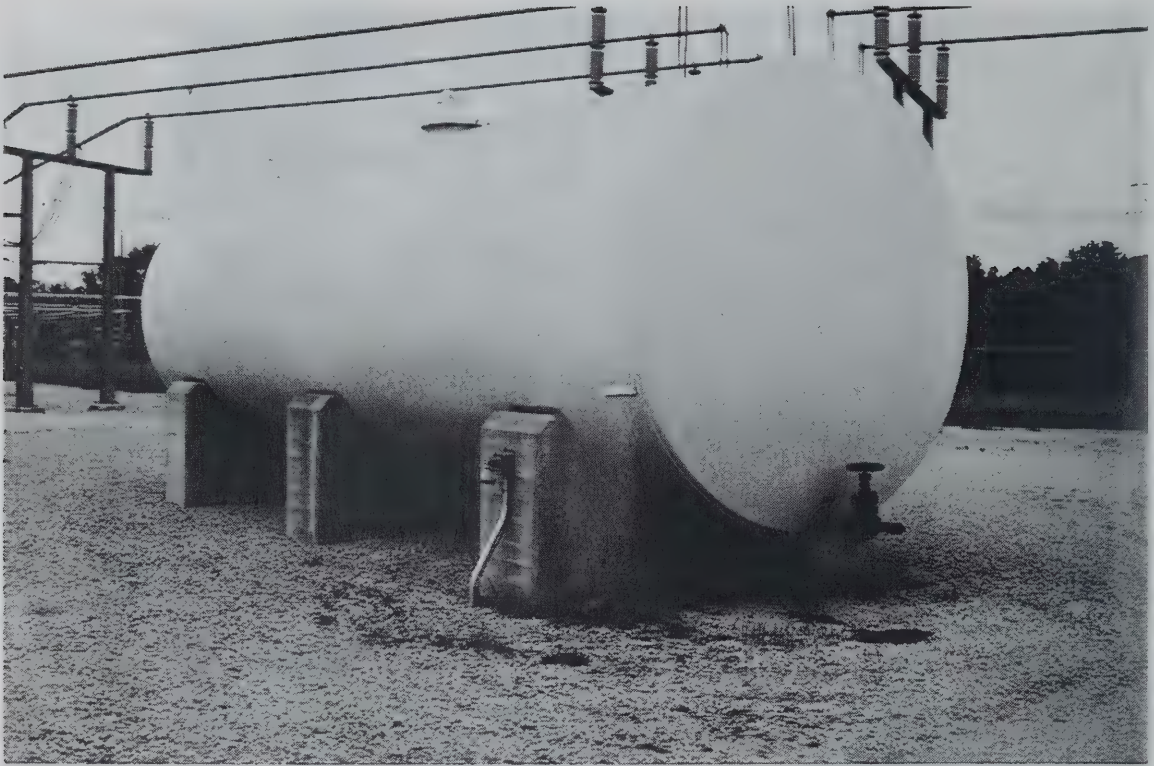
Figure 5.155 Horizontal tanks are frequently unsecured to their cradles.

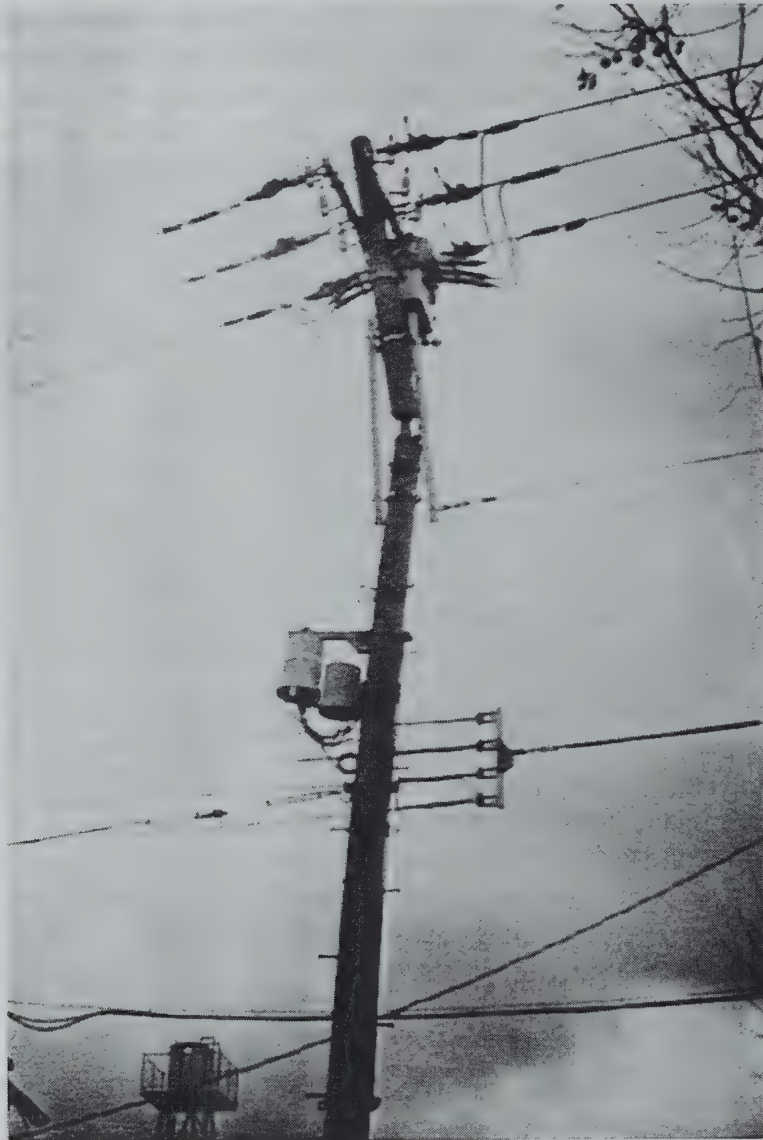
Figure 6.4 Concrete poles in Kobe, Japan, earthquake were severely damaged.

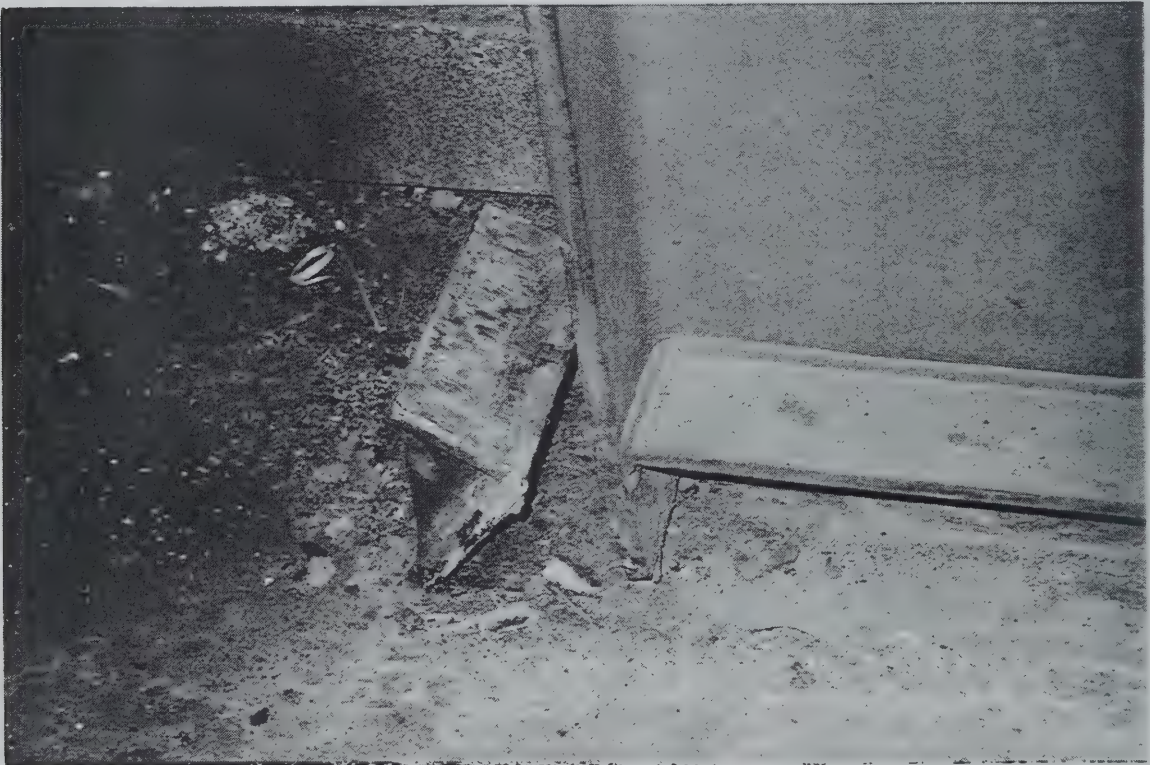
Figure 7.2 Seismic stops are provided to limit lateral movement of the suspended steam generator. These stops may be damaged, but still perform their function.

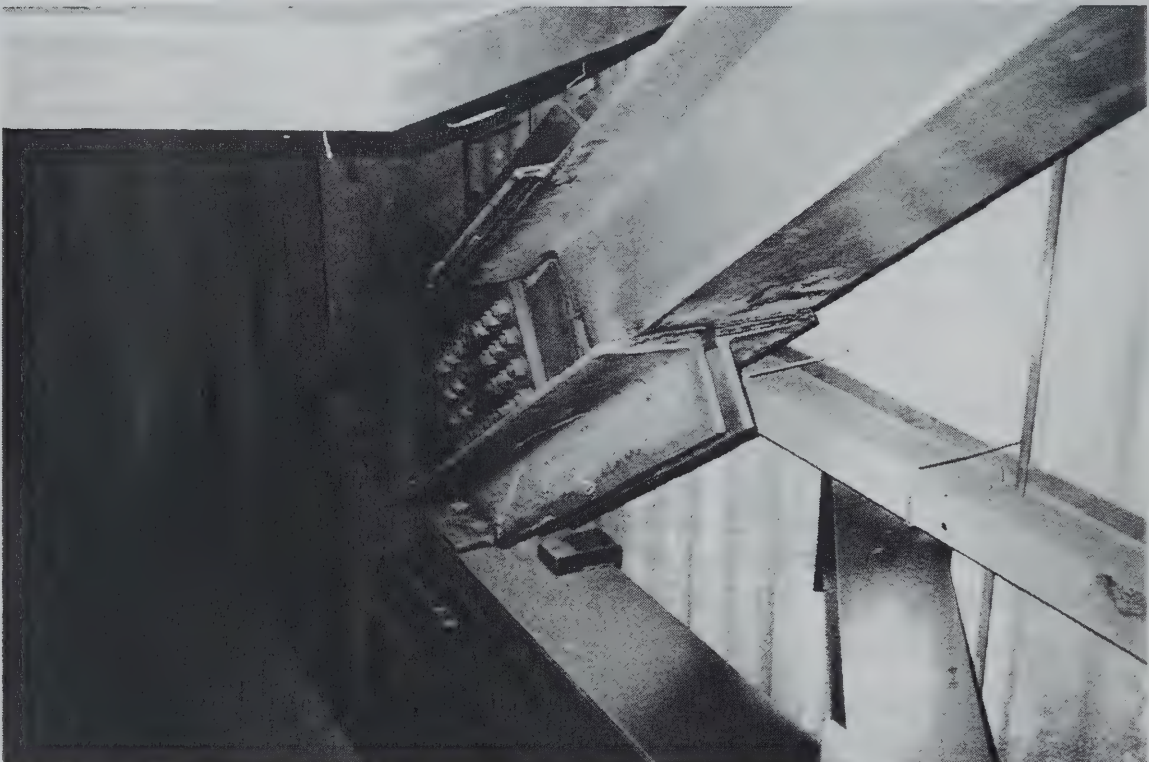
Figure 7.7 A brace in the steam generator support structure failed and is shown after it was repaired.
